FLIGHT MEASUREMENTS OF THE FLYING QUALITIES

OF AN F6F-3 AIRPLANE (BUAER NO. 04776)

II - LATERAL AND DIRECTIONAL STABILITY AND CONTROL

MEMORANDUM REPORT

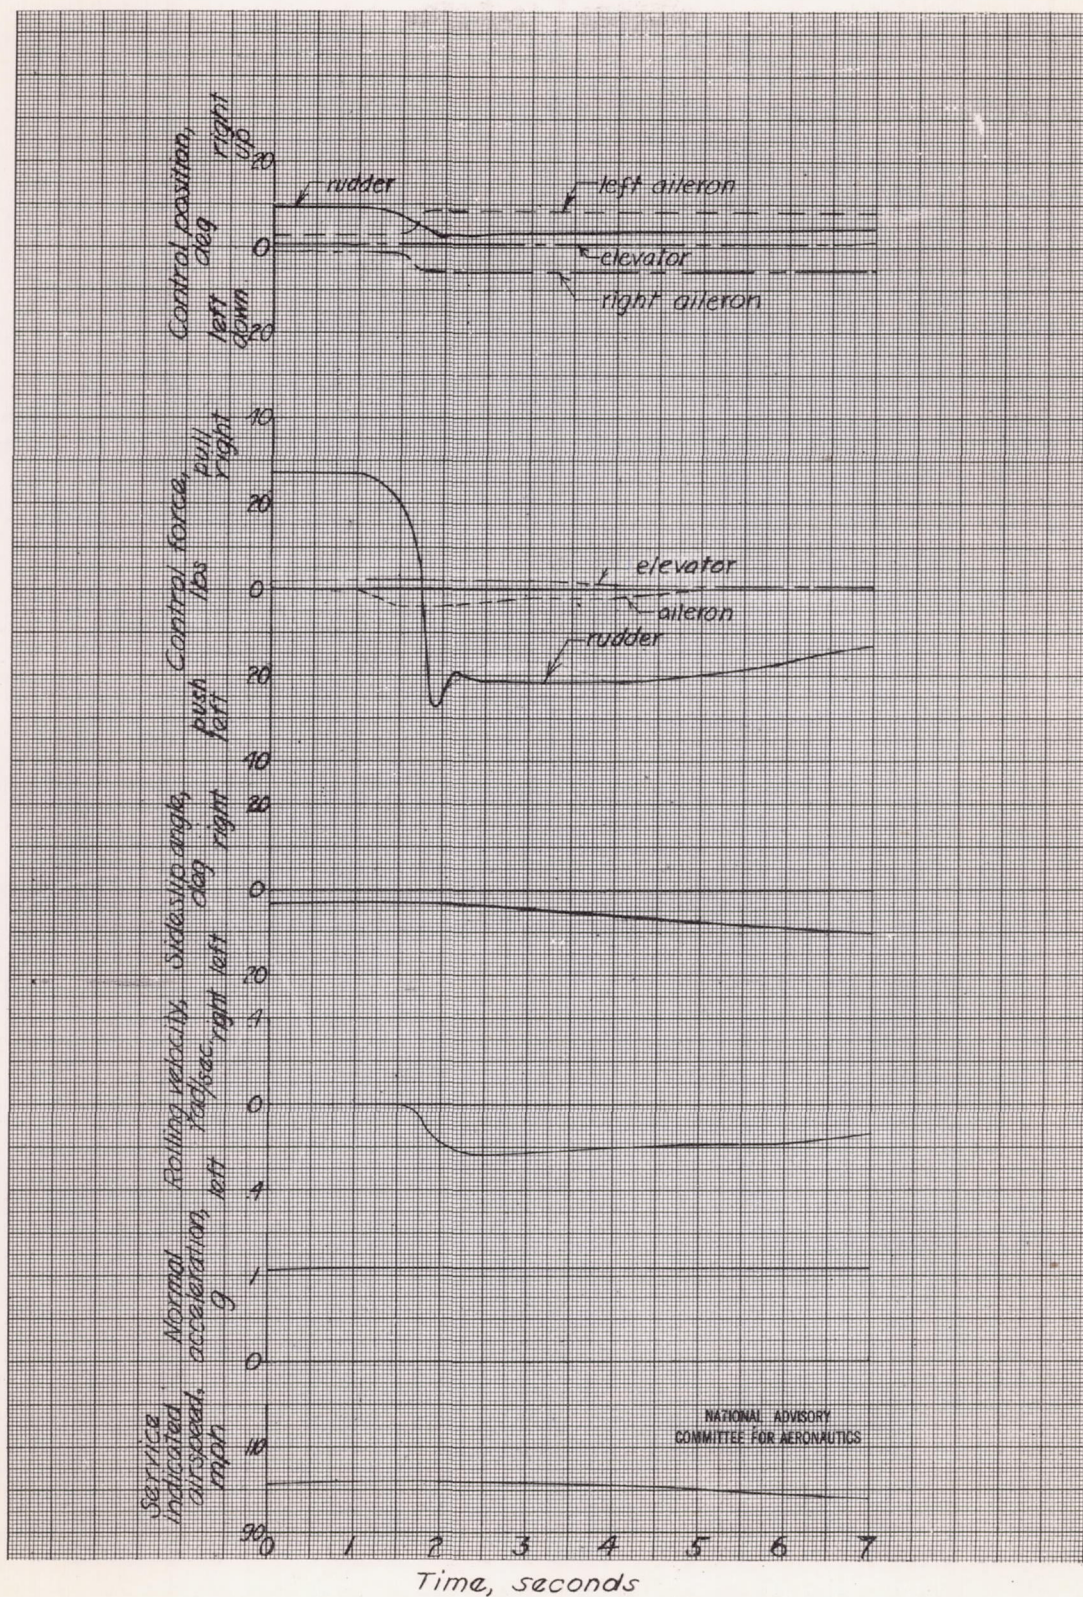
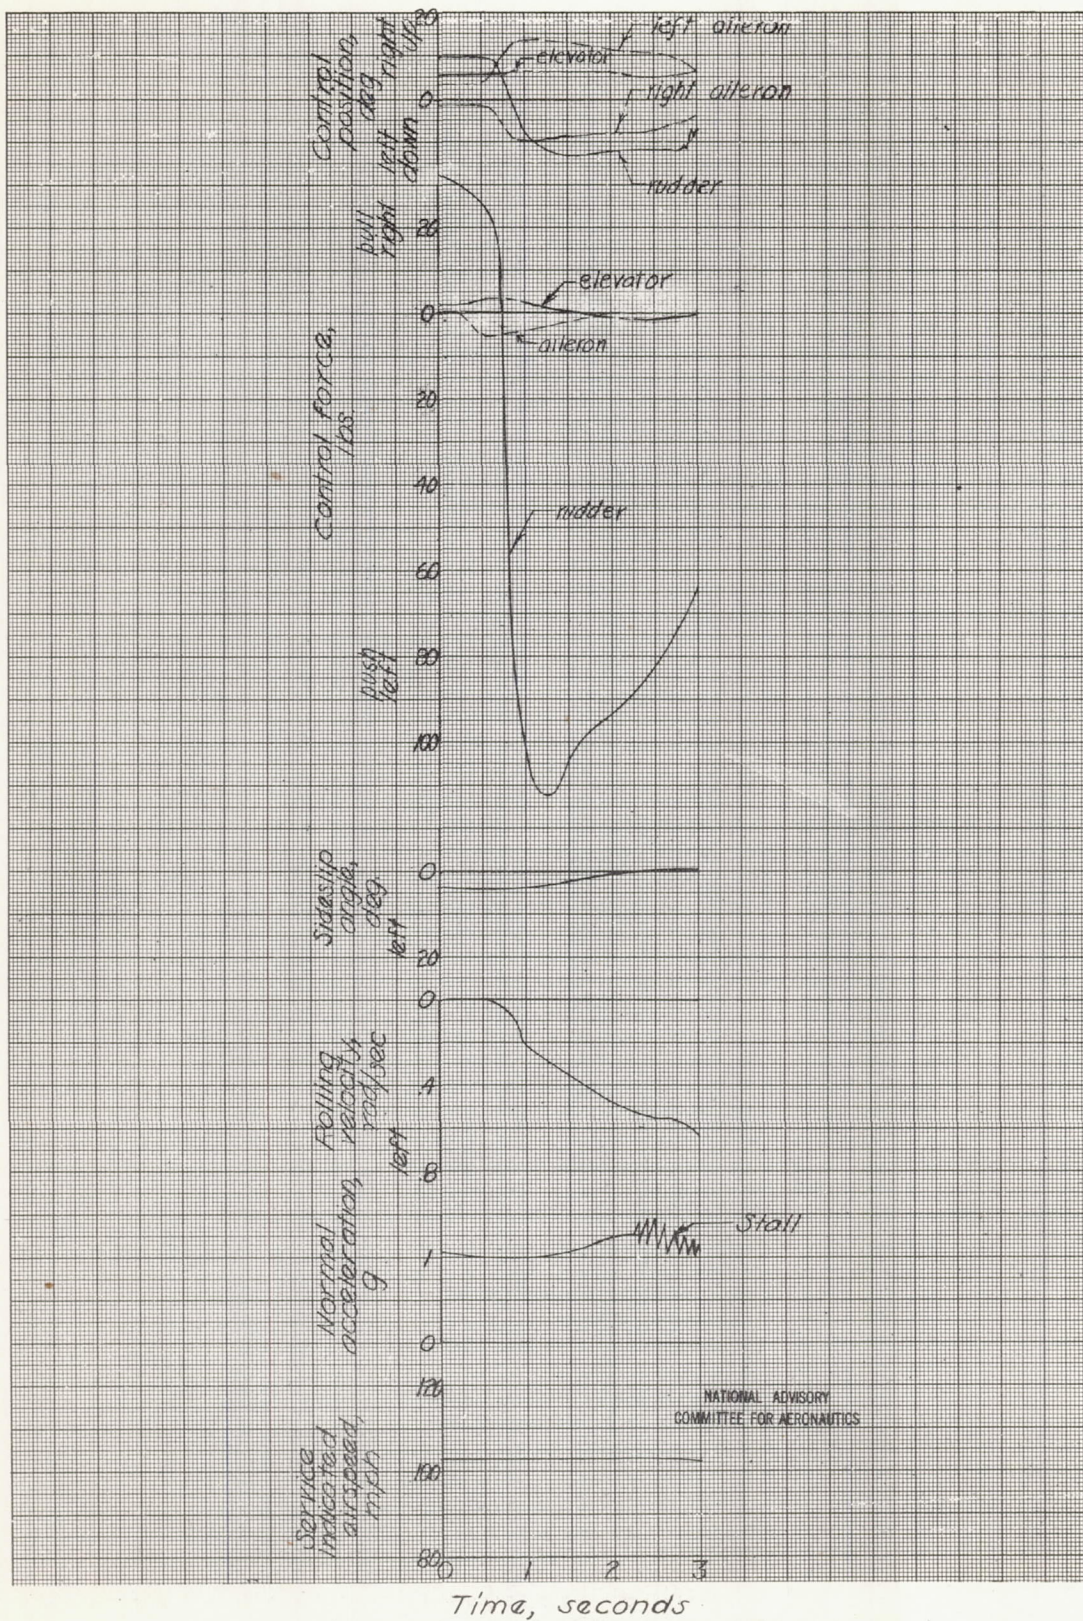
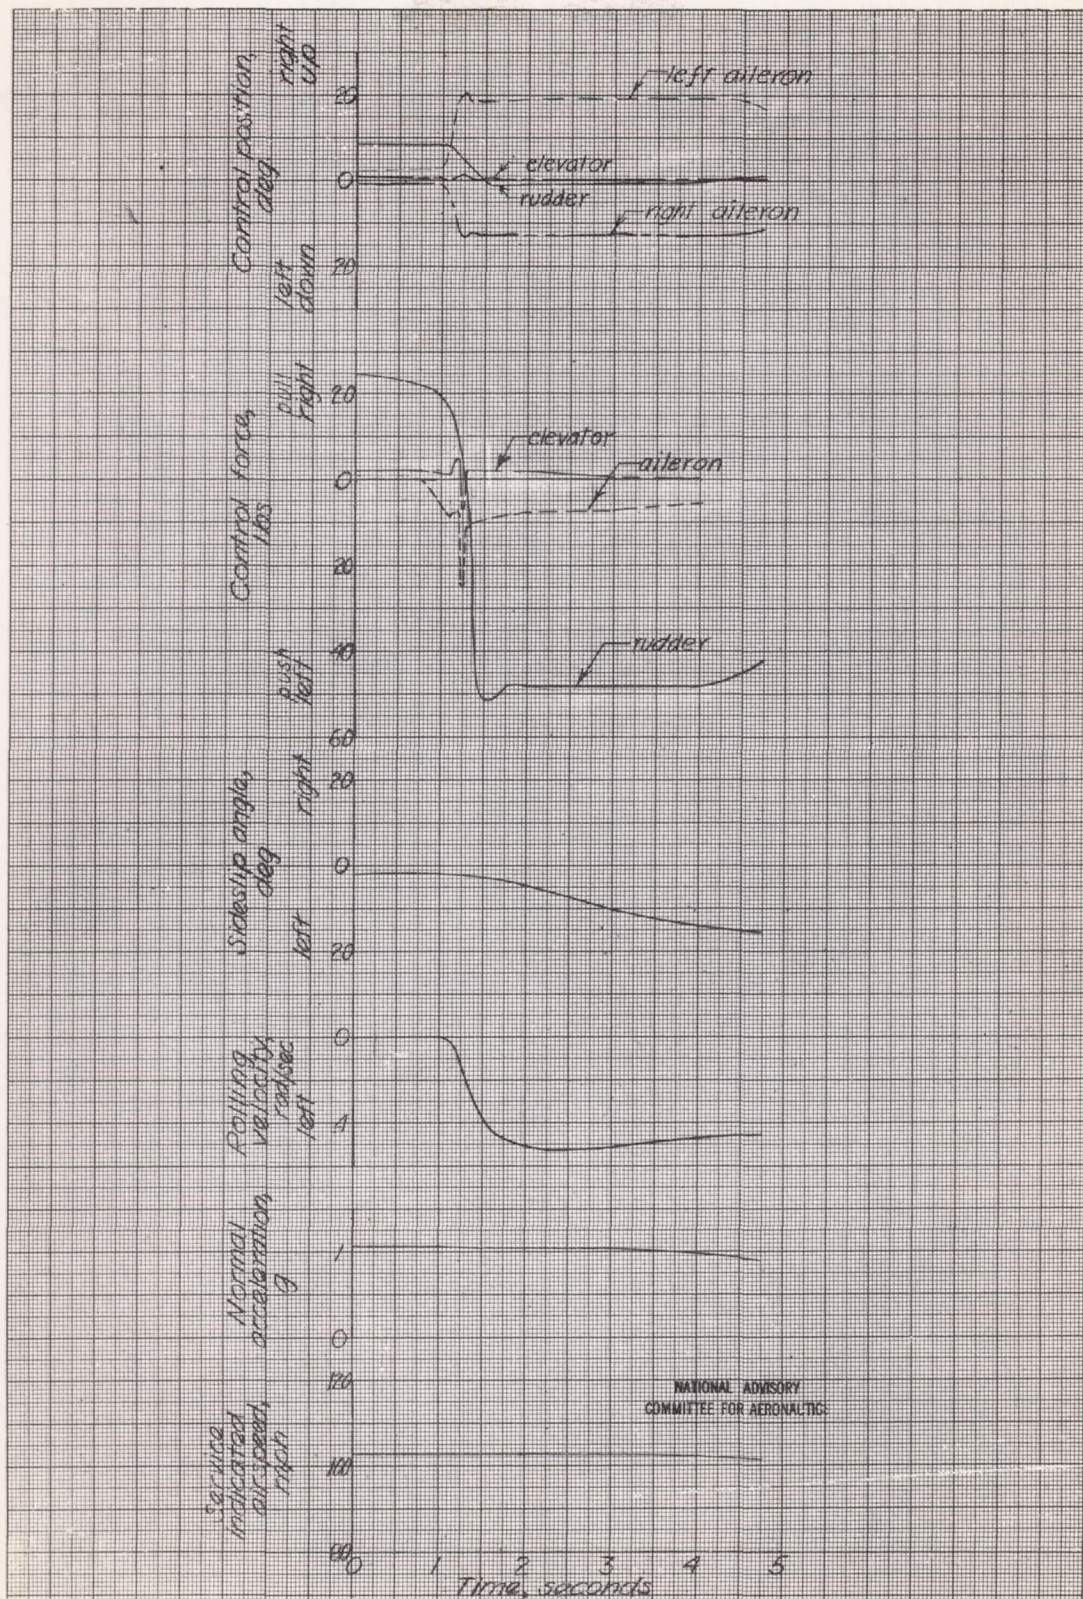
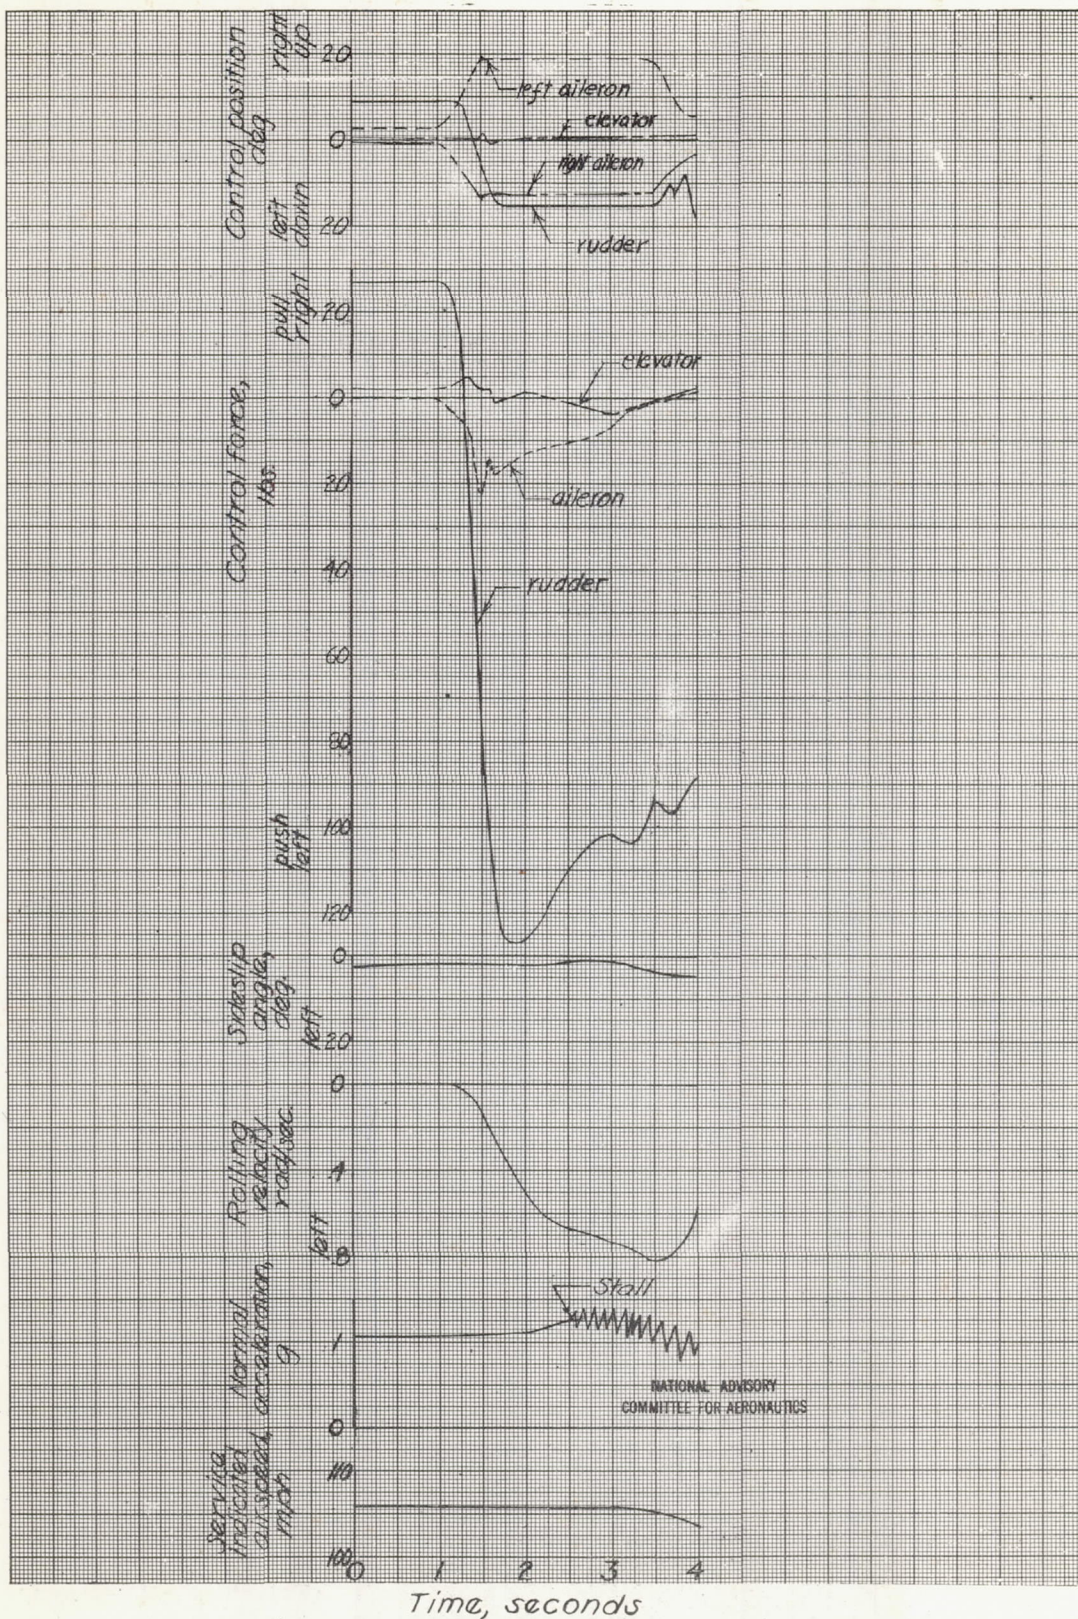
Figure 37.- Time history of rolling out of a right turn using partial aileron control and less rudder than necessary to overcome adverse aileron yaw. Clean condition, power for level flight, F6F-3 airplane.

Figure 38.- Time history of rolling out of a right turn using partial aileron control and more rudder than necessary to overcome adverse aileron yaw. Clean condition, power for level flight, F6F-3 airplane.

Figure 39. - Time history of rolling out of a right turn using full aileron deflection and less rudder than necessary to overcome adverse aileron yaw. Clean condition, power for level flight, F6F-3 airplane.

Figure 40.- Time history of rolling out of a right turn using full aileron and slightly more rudder deflection than necessary to overcome adverse aileron yaw. Clean condition, power for level flight, T-6A-3 airplane.

1. The power of the rudder in overcoming adverse aileron yaw was determined in rolls out of turns. Rolls were made where the pilot used less rudder deflection than he thought necessary to overcome adverse yaw and where the pilot used more rudder than he thought necessary to overcome adverse yaw. These maneuvers were made in the clean condition with power for level flight. Typical maneuvers of this type are shown in figures 37 to 40. It can be seen from inspection of these figures that 15° of rudder deflection is sufficient to maintain zero sideslip while using full aileron deflection at approximately 105 miles per hour. The change in rudder force is considerable (154 pounds) but is within the specified limit of 180 pounds (references 2 and 3).

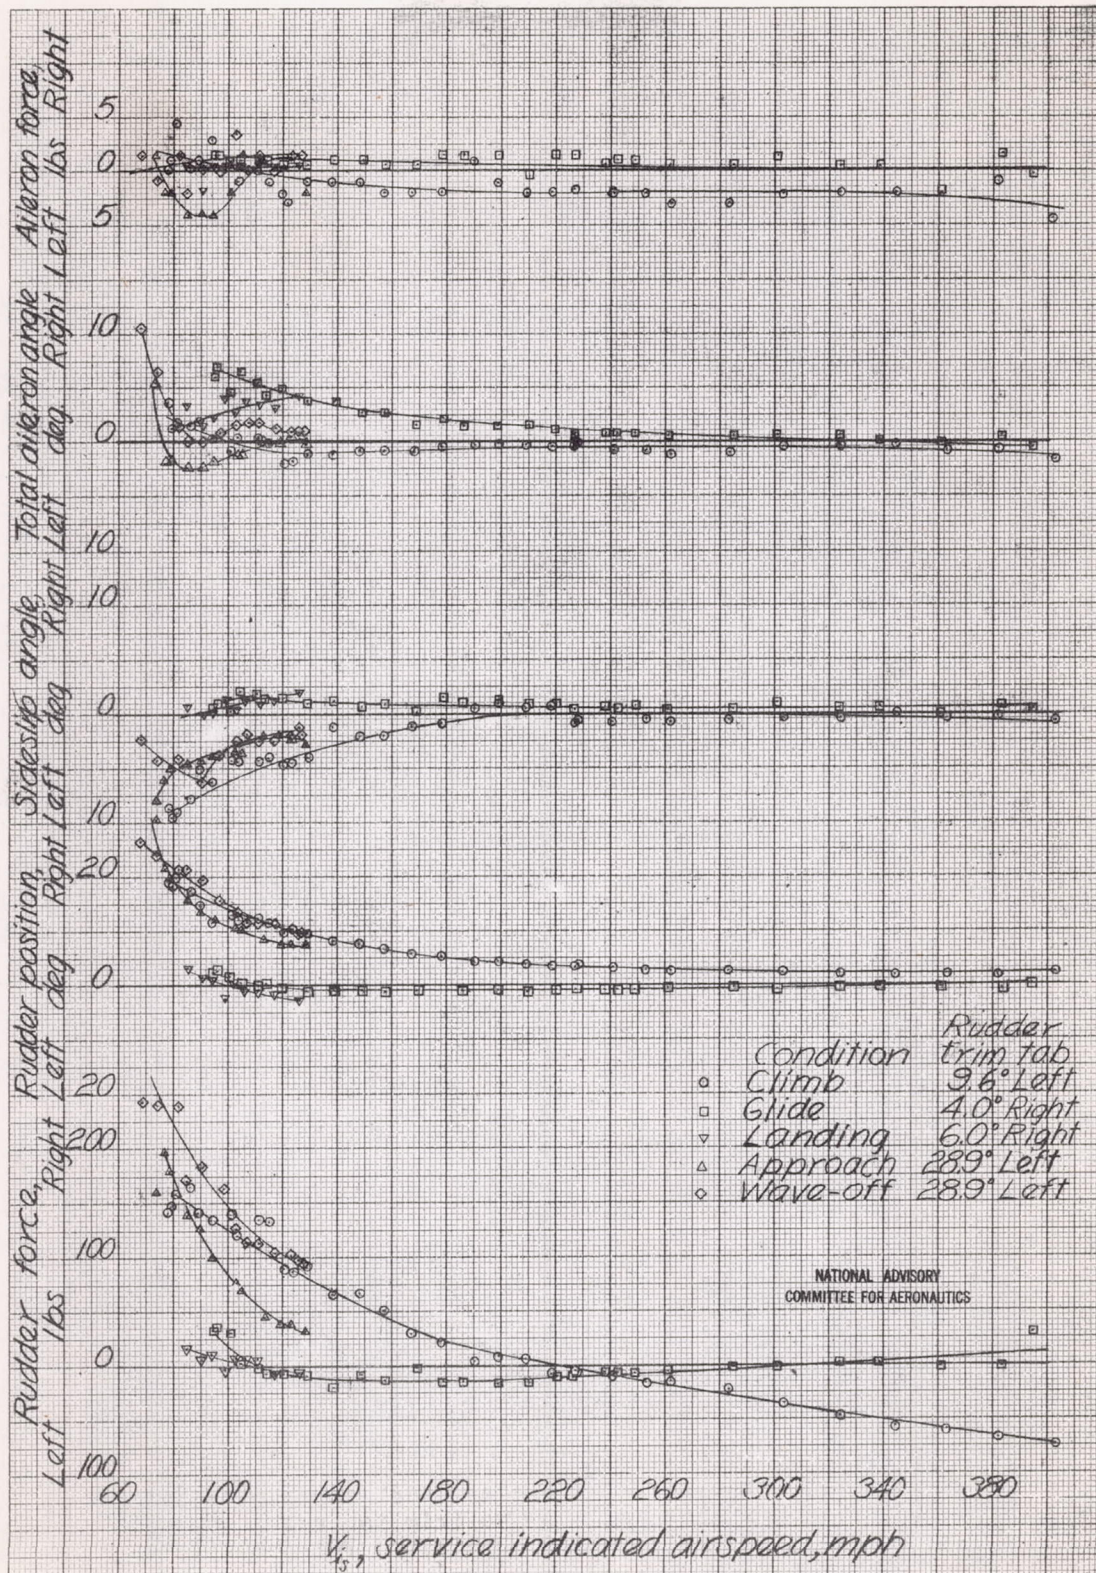
Figure 41. - Directional and lateral trim characteristics, F6F-3 airplane.

4. The directional trim characteristics were determined by measuring the rudder forces and angles required to trim at various speeds. These data are presented in figure 41 as the variation of rudder force and angle with indicated airspeed for various flight conditions. Figure 41 also shows the variation of aileron angle and force, and sideslip angle with indicated airspeed. There is no requirement specified for the change in rudder trim force with speed, but the pilots felt that in the case of the F6R-3 these changes in force were excessive. The pilots also reported a rudder shake which was present throughout the speed range in all flight conditions, which may be caused by a turbulent flow behind the elevator cutout.

The power of the rudder trim tabs was measured in a manner similar to that used to determine the power of the elevator tabs. Measurements were made in the gliding and climbing condition. Figure 41 shows the variation of rudder pedal force with speed for two trim-tab settings in the gliding and climbing condition. The data were used to determine the change in rudder pedal force per degree trim-tab deflection. This factor is plotted as a function of indicated airspeed in figure 42.

No quantitative measurements were made of the power of the aileron trim tab. The aileron trim forces were small as shown by figure 41. The aileron trim tab was reported by the pilot to be adequate for trimming the airplane within the conditions and speed range tested.

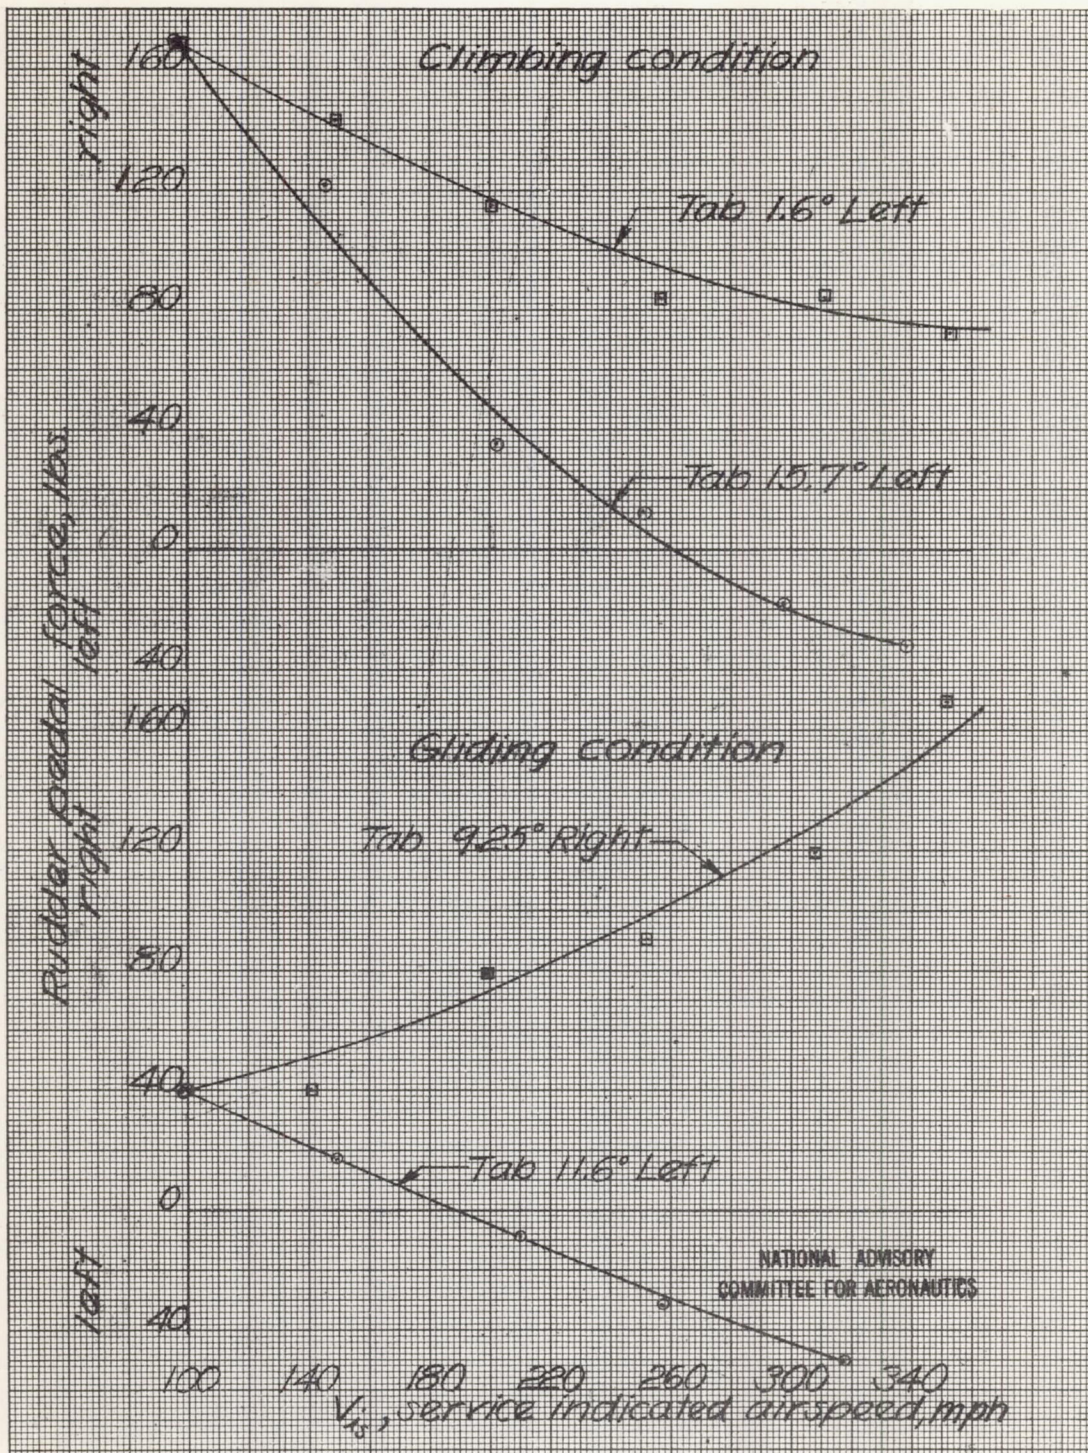
Figure 42. - Variation of rudder pedal force with indicated airspeed for two trim tab settings, gliding and climbing condition, F6F-3 airplane.

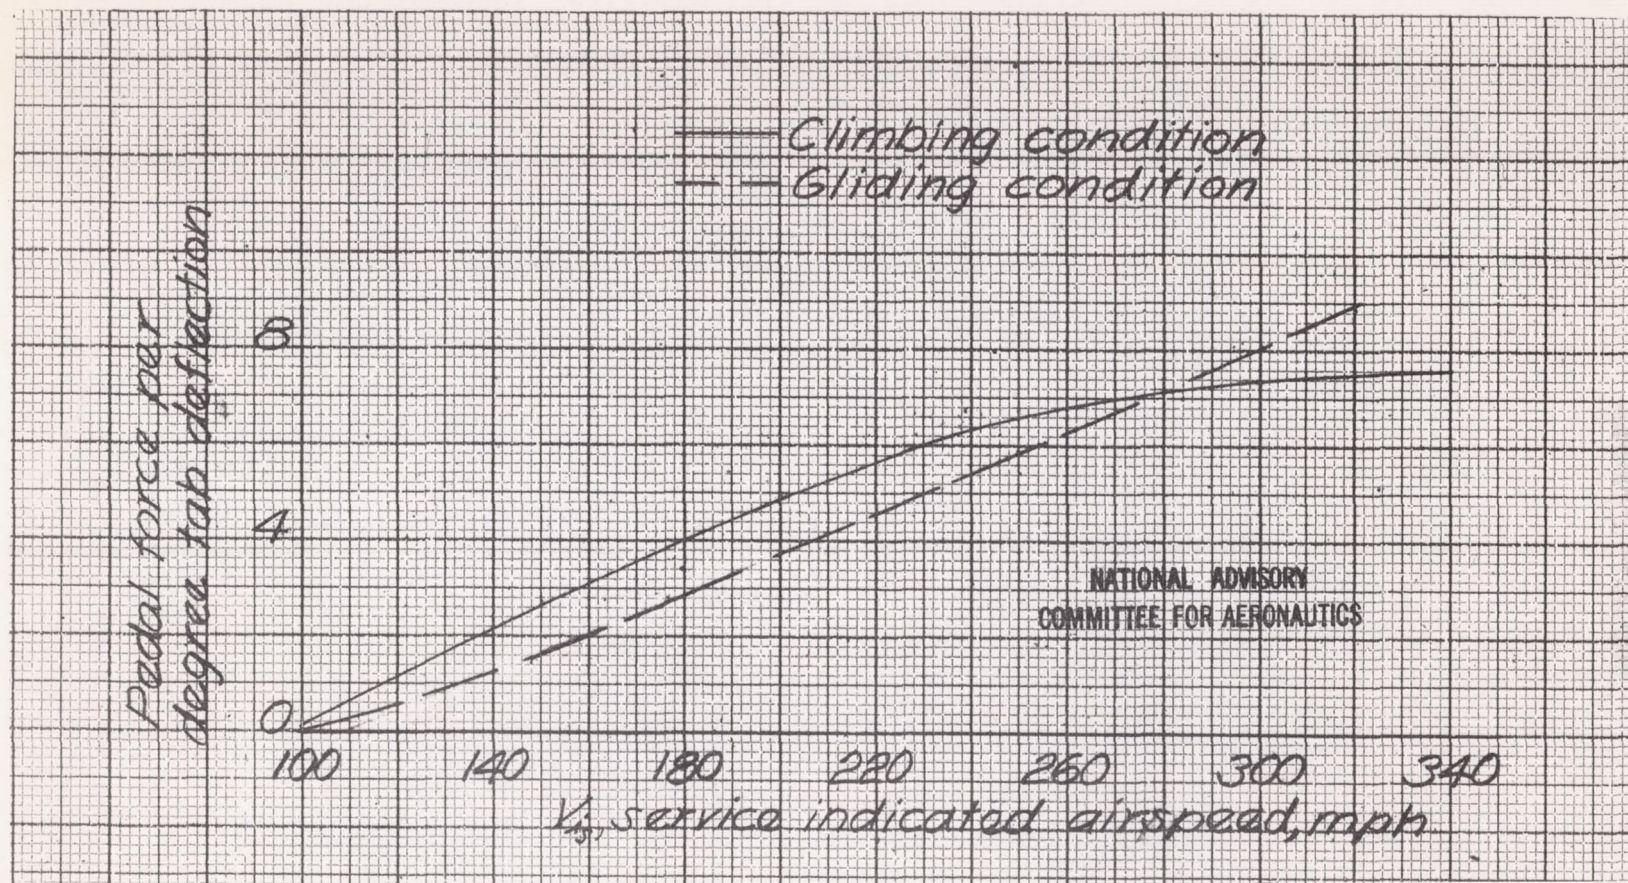
Figure 43. - Variation of rudder pedal force per degree trim tab deflection with indicated airspeed, gliding and climbing condition, F6F-3 airplane.

From the data shown on figures 41 and 43, the following may be concluded regarding the power of the rudder trim tab of the F6F-3 airplane:

1. The rudder pedal force could not be trimmed to zero below approximately 155 miles per hour in the climbing condition.
2. The rudder trim tab was adequate in the gliding condition from approximately 100 miles per hour to the highest speeds tested.
3. The rudder pedal force could not be trimmed to zero with full deflection of the trim tab in either the approach or wave-off condition in the speed range tested.
